Secondary Craniosynostosis and Elevated Intracranial Pressure with Functioning Shunt: An Imaging Report

Mazzola CA et.al. Secondary Craniosynostosis and Elevated Intracranial Pressure with Functioning Shunt: An Imaging Report. J Clin Med Img 2021; V5(5): 1-3.

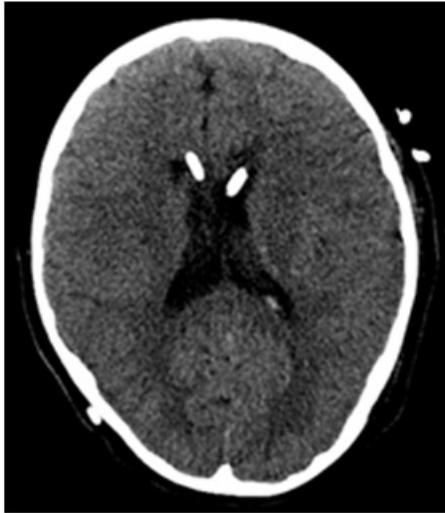
Figure 1A: CT of the brain without contrast in the axial plane after the left ETV and ventricular drain placement. Right frontal shunt catheter is shown in the right lateral ventricle and a left external ventricular drain in the left ventricle. Lateral ventricles are small.

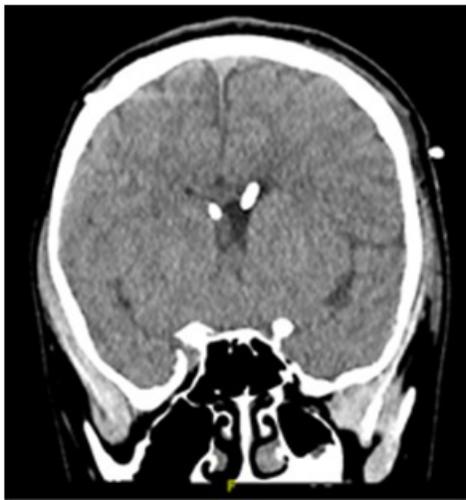
Figure 1B: CT of the brain without contrast, in the coronal plane. Right frontal shunt catheter is shown in the right lateral ventricle and a left external ventricular drain is visualized in the left ventricle. Lateral ventricles are small and third ventricle was slit-like.

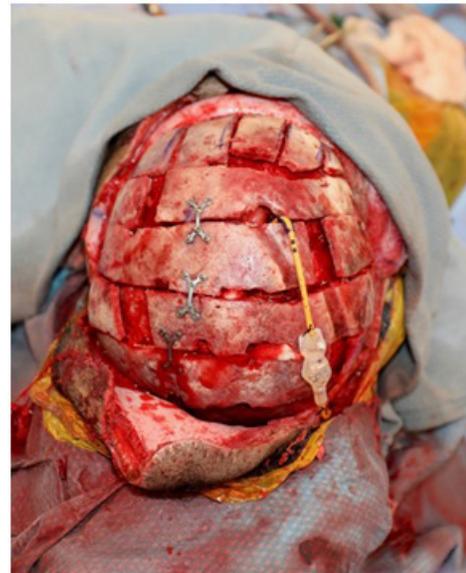
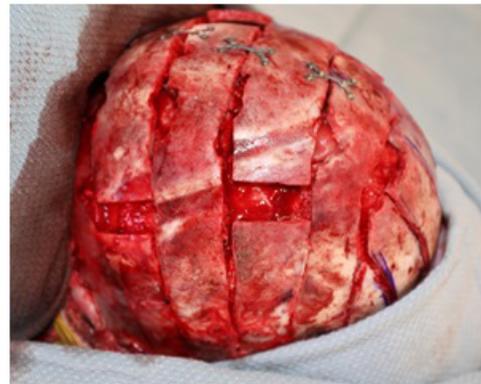
Figure 3A and 3B: Intraoperative photograph taken during cranial expansion and cranial vault reconstruction surgery. **A.** Image shows a sagittal view of the skull vault craniectomies, prior to shunt replacement. **B.** Image shows multiple strip craniectomies to open up the skull in the parietal area bilaterally in a vertex view. **Note replaced shunt on the right.**

A cranial vault expansion with multiple craniectomies was performed. The ventricular catheter was replaced and a Cert as programmable valve (Codman) was used, so that reprogramming after magnetic resonance imaging would not be necessary (Figure 3A and B). Plastic surgery was consulted to perform the cranial vault remodeling. A right ICP monitor was placed for perioperative ICP management. A post-operative 3D CT scan was performed (Figure 4). The ICP's after surgery normalized and eventually, on post-operative day 2, the ICP monitor was removed. The child was discharged on post-operative day 5 and has been doing well.
